Discover The **XCASE**
by novexa

My maintenance partner !

This is why NOVEXA has chosen to develop and give access to its XCase gear wear monitoring program.

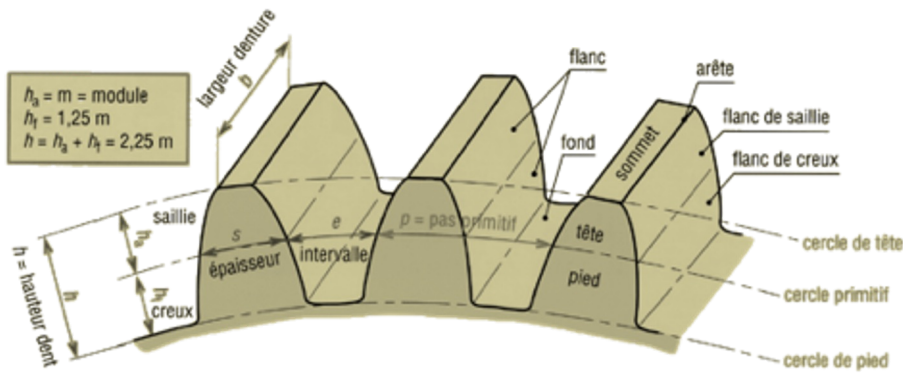
Required data

Désignation	Symbole	Proportion
Nombre de dents	Z	13 mini
Module	m	
Diamètre primitif	d ou d_p	d = m.Z
Diamètre de tête	d_a	d_a = d + 2.m
Diamètre de pied	d_f	d_f = d - 2.5m
Pas primitif	p	p = π.m
Hauteur de denture	h	h = 2.25m
Hauteur de saillie	h_a	h_a = m
Hauteur de creux	h_f	h_f = 1.25m

The following characteristics will have to be gathered for each equipment in order to manufacture the associated steel templates:

- Module (m)
- Pressure angle (α)
- External diameter (d_a)
- Number of teeth (z)
- Helix angle (β)

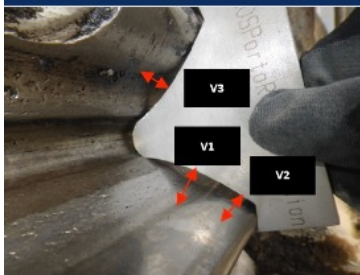
Wear measurements

- ✓ V1: active flanc maximum wear
- ✓ V2: active flanc minimum wear
- ✓ V3: non working side maximum gap

XCase is based on the use of control templates. They allow to accurately measure the profile deformation through 3 simple measurements:

- V1 = maximum wear
- V2 = minimum wear
- V3 = non working side maximum gap

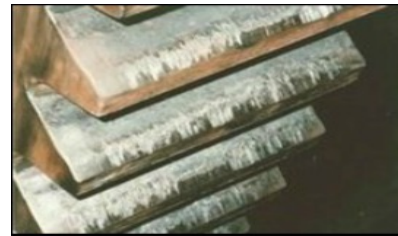
Scuffing is a damage related to a metal/metal contact during the meshing resulting in tearing of material. Scuffing occurs when the lubricating film breaks. They can be localized at a precise point, on the sliding zones only or finally on the whole surface.

Spalling is a dangerous damage whose representation is the removal of metal by plates. This is linked to a too high hertz pressure very often linked to a bad distribution of the load. For this type of damage, waiting is detrimental because the extension is done in the under layer.

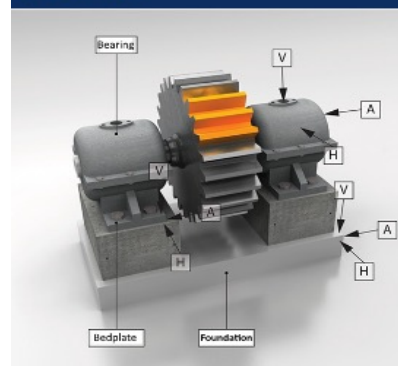
- Vibrations readings on bearings, bedplates and foundations
- Pinion / gear temperature readings
- Surface damages pictures

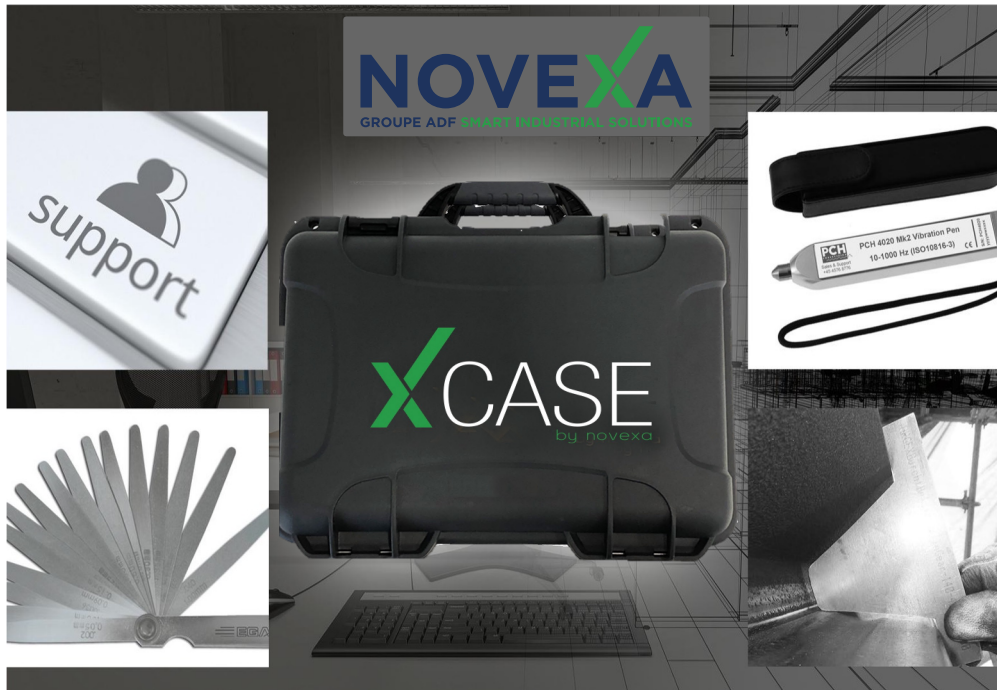
What you will find in the XCase

- Transportable briefcase
- User manual
- Access code
- Feature gauge set
- Gear and pinion steel templates (V1, V2 ,V3)
- Vibration pen (mm/s - RMS)

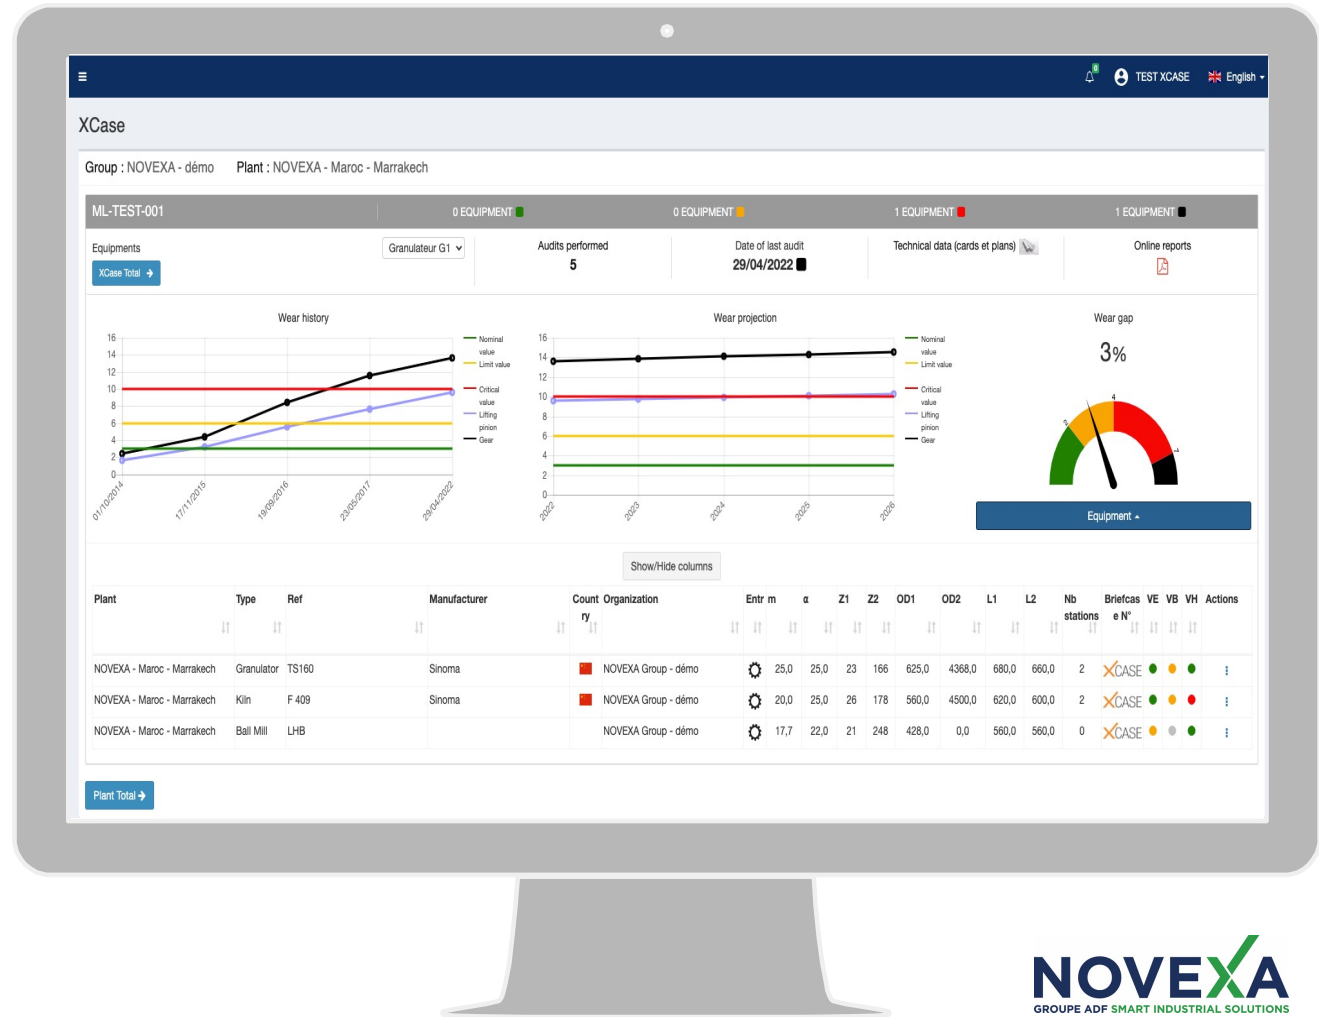
XCase application

- Simplified reading thanks to NOVEXA color codes
- History + wear projection through 2 separated graphs
- Cursor on the right helps you reading risks linked to equipment wear
- Date of last audit
- Access to technical data
- Switch to another equipment in one click through the drop-down menu
